PROJECT
IntegraRack

TITLE
IR-15 Solar Racking System Data Sheet
IR-15RF1000

Subject: Simulated Wind Load, Snow Load, and Horizontal Racking Load Testing on IR-30 Solar Racking System.

INSPECTION AND TEST REPORT

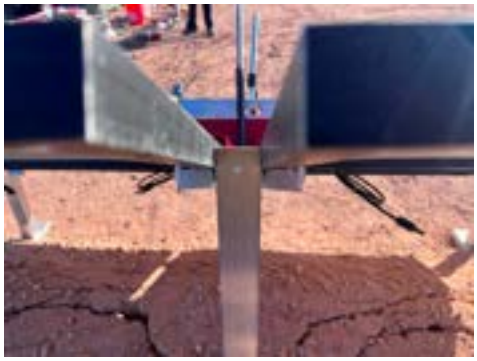
PHOTO 13: IR-F2 Clamp bracket after completion of testing

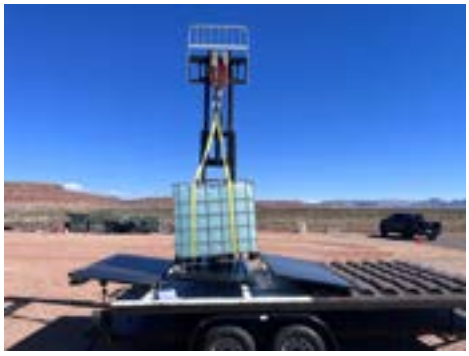
PHOTO 1: Weighing the large water tank

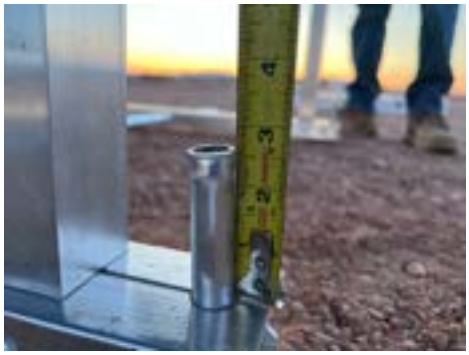
PHOTO 4: 'Stickout' measurement example at Spike #3
